KENTUCKY HISTORIC RESOURCES
Individual Inventory Form

Resource # Be-281
Boone County

1. Name of Resource:
Norman, L.C., House

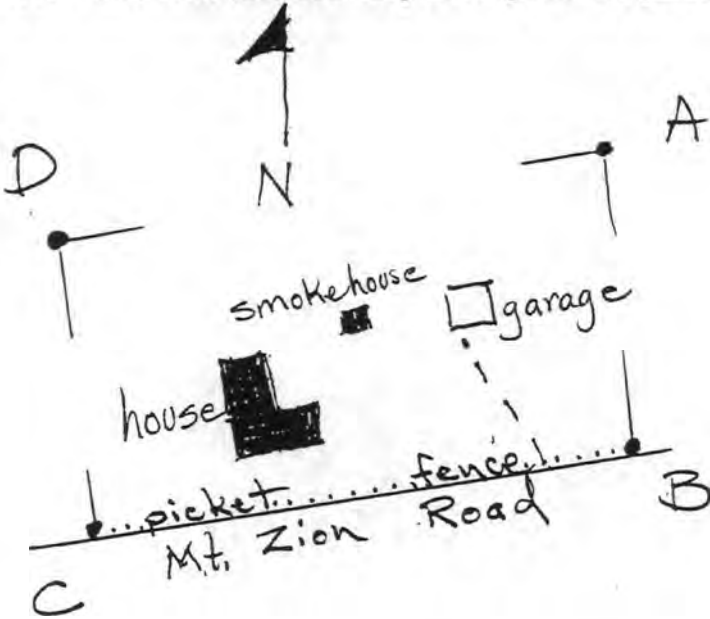
44. Site Plan (and boundary description and justification for N.R. sites):

The boundary rectangle, shown by points A, B, C and D, is approximately 175' x 150'. It includes the house, the two outbuildings, and sufficient acreage to provide a setting. The boundary D-A is on the north side of Mt. Zion Road.

Beginning at the point where the north and east property lines of tax parcel 51-63 intersect (A), follow the property line 150' south southeast to the north side of Mt. Zion Rd. (B). Then proceed 175' west southwest along Mt. Zion Rd. (C) to the west property line. Then proceed north northwest 150' (D), turning east northeast 175' to the point of origin.
