KENTUCKY HISTORIC RESOURCES INVENTORY

Site No. Tm-89

1. Historic Name(s) Preston House; Norfolk Plantation		22. ADD County No. Ky. / Trimble 1 1 2	
Original Owner		23. U.S.G.S. Quadrant (15/75') Madison West G.I.S. Mod. <input type="checkbox"/>

Preston House (Trimble County MRA)
Trimble County
KENTUCKY

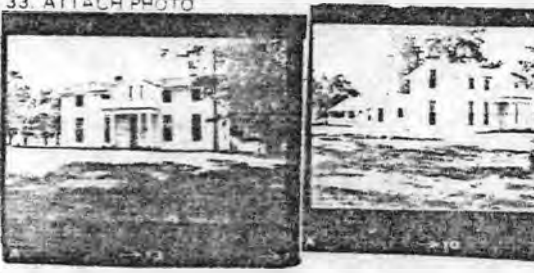
15. Original Use Dwelling <input checked="" type="checkbox"/>		33. ATTACH PHOTO	
16. Present use Dwelling

17. Condition Very Good <input checked="" type="checkbox"/>

18. Description Situated on rolling farmland, the Preston House is a two-story brick building which has been weatherboarded. Fenestration is five-bays with a recessed central entrance with five-pane crystal glass sidelights. A one-story, one-bay portico with bracketed and dentilled cornice and a balustraded desk enhances the entranceway. Long, narrow (Continue on Back)		No. Stories Two <input checked="" type="checkbox"/> Single Pile XX NA <input type="checkbox"/> Double Pile <input type="checkbox"/> Floor Plan Central Passage <input checked="" type="checkbox"/> Structural Fabric Brick/Frame A. <input checked="" type="checkbox"/> B. <input checked="" type="checkbox"/> Decorative Fabric Sawn Weatherboard A. <input checked="" type="checkbox"/> B. <input type="checkbox"/> Roof Form Gable

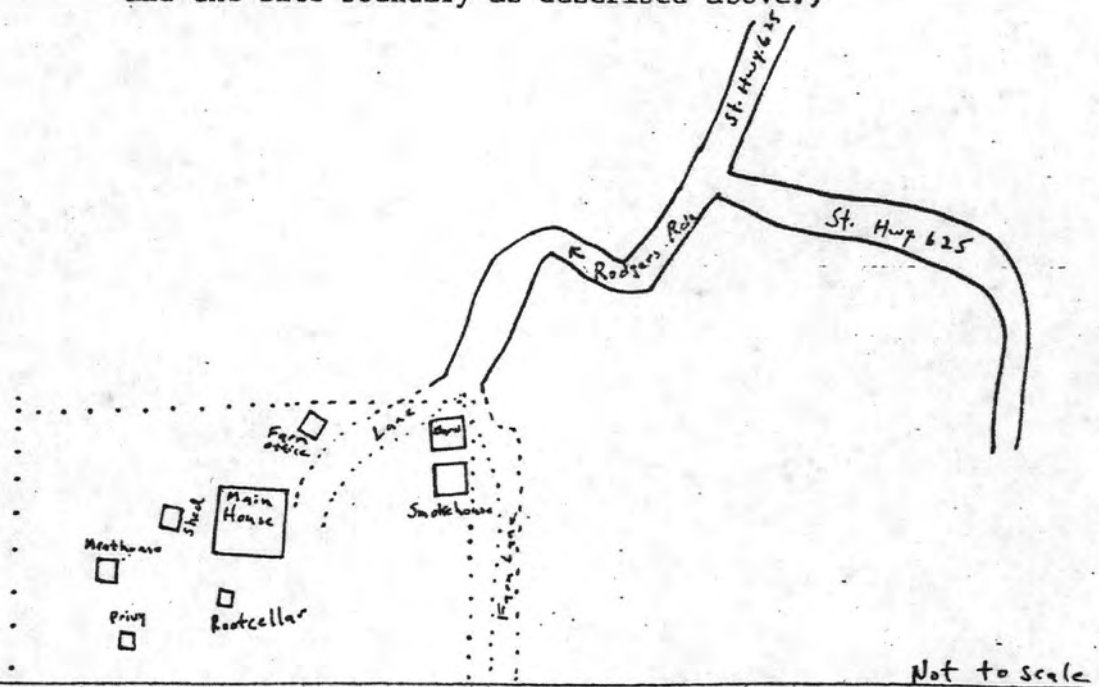
Sketch of Site Plan (Showing outbuildings, structures, landscape features and the site boundary as described above.)

A rather large collection of outbuildings associated with the dwelling exist today. They are:

- a. One-story brick rootcellar. One-bay. Wood shingle hip roof. Arched brick supports above the bays. Common bond with a row of headers every six rows. Directly behind the house (oldest)

- b. One-story frame meathouse. Two-bay. Hip roof. Wooden shingle roof. Limestone foundation.
 - c. One-story frame privy. Brick foundation.
 - d. One-story frame shed.

- e. One and one-half story frame dwelling. Slave and servant quarters. Three-bays with side entrance. Interior chimney. Brick foundation.
 - f. One-story brick with side entrance. Common bond with row of headers every six rows. Original structure had liproof and interior gable-end chimney. Window on brick portion is 6/6 pane with arched brick support. One-story bay porch, other windows 3/6 pane. One of the oldest buildings on the farm. Was used as a Catholic Chapel and School.

- g. One and one-half brick smokehouse. According to local tradition, the building was constructed for use as a slave jail. The structure has three levels a basement where leg irons still exist, the main floor, and a loft. The building is one-bay with two brick row supporting arch. Executed in common bond with a row of headers every four rows, and reinforced by cast-iron tie ends secured by cast-iron star-shaped retainers. Hip roof.

- h. One and one-half story frame barn.
 - i. Farm Office. A one-story frame structure. One-bay with projecting pedimented porch. Exterior gable-end stone chimney. Gable roof. Windows are 6/6 pane. Brick foundation.

Beginning at a point on the east side of the lane leading to the house, approximately 200' from the house, proceed 200' in an eastward direction; thence 650' in a southward direction along the farm lane; thence 400' in a westward direction; thence 650' in a northward direction; thence 200' in an eastward direction to the point of origin. The boundary is drawn to include the house and outbuildings.
