KENTUCKY HISTORIC RESOURCES Individual Inventory Form

Resource	#	Be-125
Boone		County

1. Name of Resource: Uitz, Ephraim, House			16. Date: Original Building 1842-1844*
2. Original Owner:			Addition []
Ephraim Uitz		_	17. Style: Federal
3. Other Names: None			Greek Revival
	ject her		18. Architect/Builder: unknown

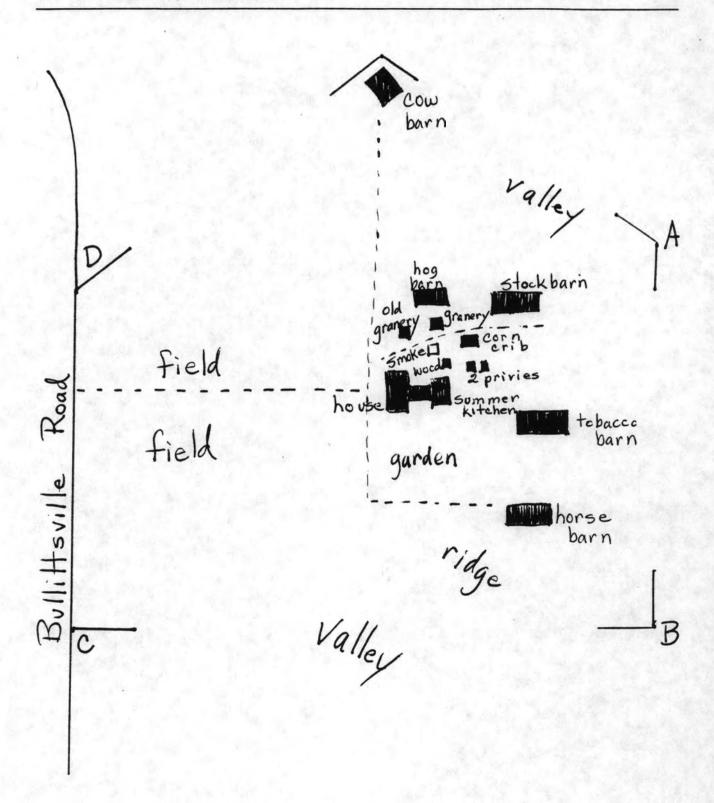
44. Site Plan: (Continued)

contributing buildings

house summer kitchen cow barn horse barn stock barn tobacco barn

hog barn

2 privies wood house

noncontributing buildings

smokehouse

Contributing Structures

Corn Crib granary granary Resource # <u>Be-125</u>
Boone County
Page <u>5</u> of <u>5</u> Pages

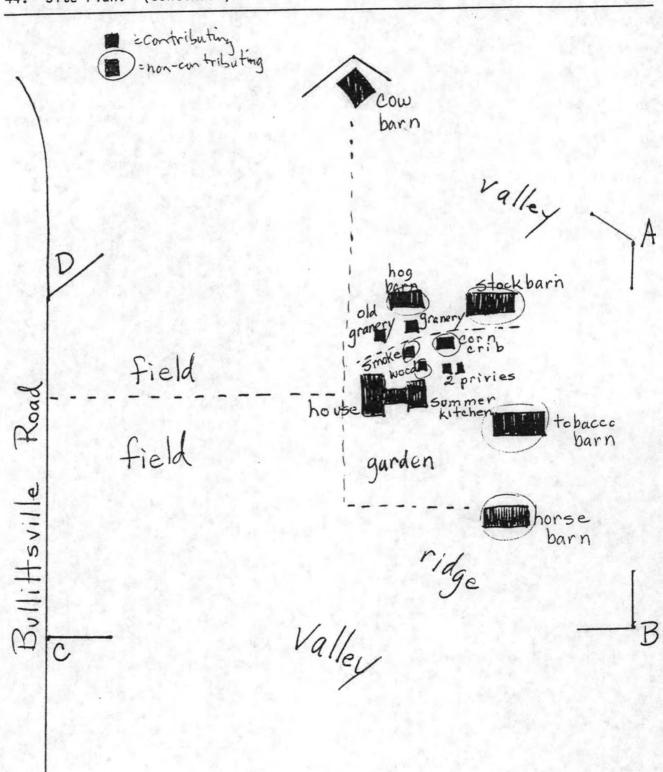
44. Site Plan: (Continued)

contributing buildings

house summer kitchen cow barn privy privy

noncontributing buildings and structures

smokehouse, corn crib, horse barn, stock barn, hog barn, wood house, tobacco barn

Contributing Structures

granary granary Resource # Be-125
Boone County
Page 5 of 5 Pages
