**National Register of Historic Places
Inventory—Nomination Form**

NORTH MAIN/NORTH ADAMS HISTORIC DISTRICT DESCRIPTION

N.MAIN/N.ADAMS HISTORIC DISTRICT STATEMENT OF SIGNIFICANCE

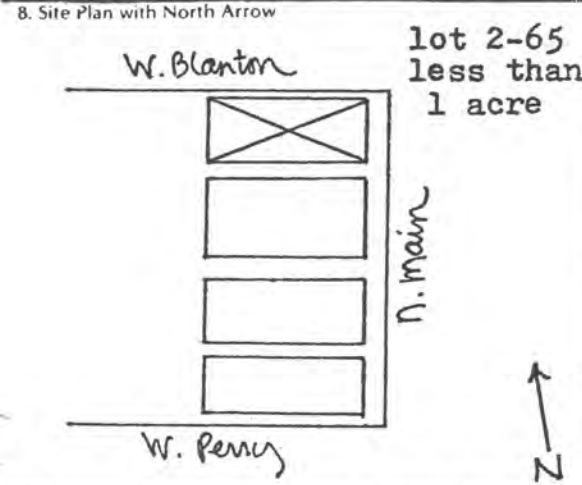
16. Description **Originally an L-plan, as shown on 1883 almanac map, 1893 and 1903 Sanborn maps show L-plan with small one-bay porch on front and another on south facade. Five-bay front; center door has transom. Windows are floor-to-ceiling 6/6 with decorative wooden lintels on corbel blocks. One window has been boarded over. Present front porch is recent addition; 3-bay with Doric columns. Photo from 1974 shows 3-bay porch with turned posts on low brick piers; that porch was added sometime (over)**
(Continue on back)

before 1925 (per Sanborn map). Box cornice returns at gable ends. Interior end brick chimneys. North facade has same windows with lintels on corbel blocks. Additions to rear (c. 1920's, per Sanborn map) include frame on rubble stone and frame on concrete block portions, a garage on the north side (basement level), and a small porch at the SW rear corner. Stone wall along north property line.

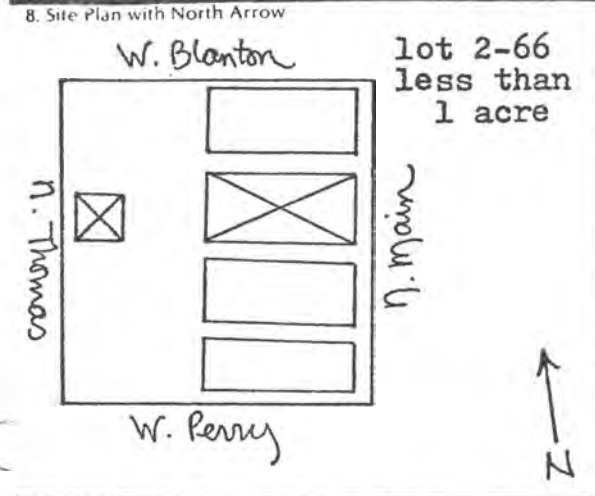
several openings from the rear porches, and the original clapboard is present on this portion of the house. There is a brick outbuilding to the rear of the property. The 1908 Sanborn map identifies this as a bake house, with an oven in the southern part. The 1925 Sanborn map identifies it as an ice house. The building is brick with square single pane windows, a center door with wooden lintel, and a standing seam metal gable roof. Repairs have been made to the north facade in concrete block. The entire property is surrounded by a low stone wall.

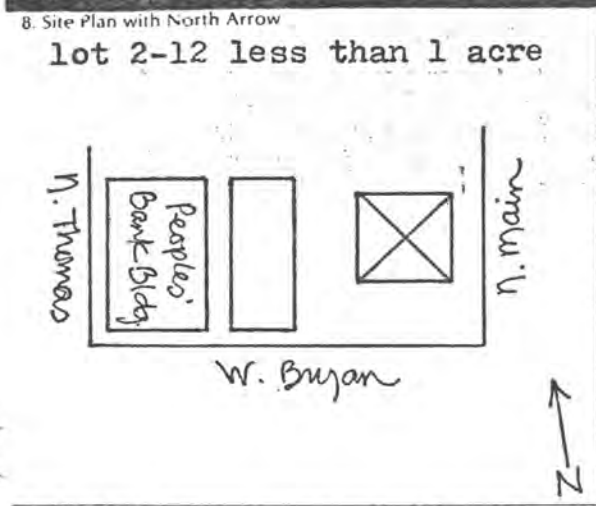
25. History **The Duncans acquired the lot and probably built the first version of the house pre-1860. They sold it to Wm. B. Roberts that year; Mrs. Roberts ran it as a boarding house for (over)**

26. Significance **One of Owenton's earliest houses, adapted over the years and reflective of stylistic changes. Integrity intact.**

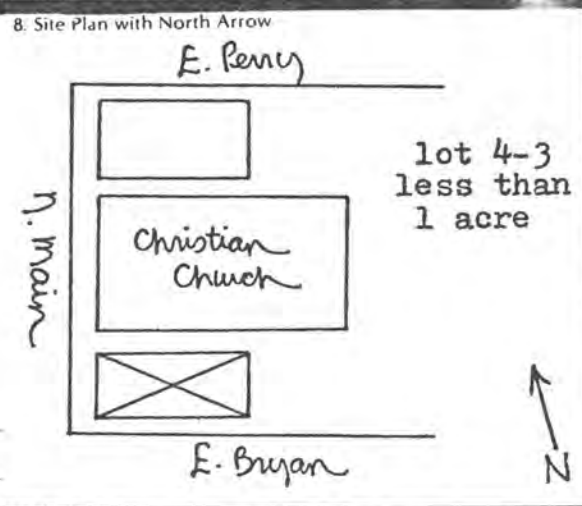
25. History **Built by A.W. Schoolfield in 1922. One of several early 20th century residences built on N. Main to replace earlier homes, indicative of commercial well-being in Owenton.**

16 continued: is raised above street level and is set back from street. Property surrounded by stone wall. House looks much the same as when built; architectural integrity intact.

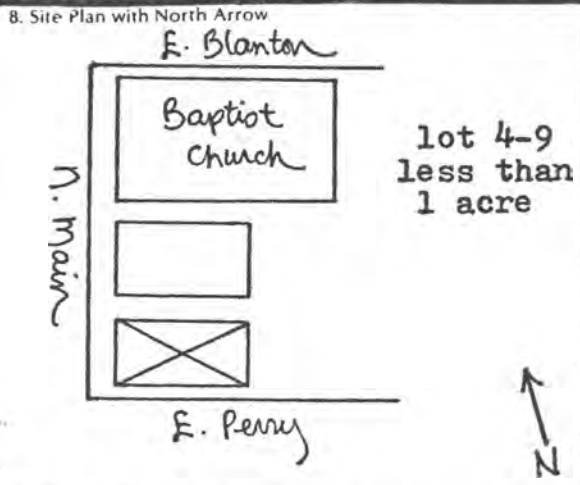
16. Description **High foundation of rock-faced ashlar. Front facade has double center door with transom. Lower window has arched art glass and brick segmental arch above. Upper windows are 1/1 double hung with stone sills and lintels. Gable end has half-round window and shingle trim. Corner tower has 1/1 windows with stone sills and lintels, conical roof with egg and dart trim. 2-bay porch has Doric columns, brackets and spindle trim. South facade has small porch with spindle trim; round art glass (over)**

at porch. Arched art glass window above porch. Other windows are single or double 1/1 with stone sills and lintels. North facade has large two-story bay; lower level has arched window with art glass panel. Other windows are 1/1 with plain stone sills and lintels. Rear facade has modern one-story brick addition with rusticated concrete block foundation and box cornice; compatible with original materials and design of the house. Box cornice continues on all facades; central brick chimneys. House is set slightly back from street; surrounded by iron fence.

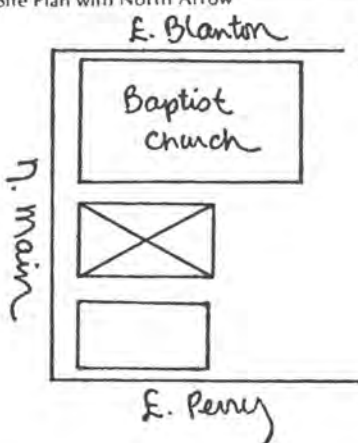
16. Description **High rock-faced ashlar foundation. 1903 Sanborn map shows 2-story front porch; present one-story porch dates to c. 1905 (per 1908 map). Double Ionic columns on low stone piers; now screened in. Lower level has entrance door to left with transom and rusticated stone lintel. Center one-story bay. Upper story has double 1/1 double-hung windows with rusticated stone sills and lintels. Small oval window in center. Decorative frieze and box cornice. Gable dormer in front slope has (Continue on Back) (over)**

16 continued: double-hung windows with Queen Anne panes; decorative gable end and box cornice. Interior end corbeled brick chimneys. South facade has two-story bay, double-hung windows with rusticated stone sills and lintels, and a corbeled brick chimney with buttressing on exterior wall. Decorative frieze and box cornice continue. North facade has two-story center bay with Queen Anne windows; tri-partite arched window with art glass panels and stone segmental arch. Decorative frieze and box cornice. Rear has small porch with bracket trim (c. 1905, per 1908 Sanborn map) and same decorative dormer as on front. House is set slightly above street level, surrounded by low wall. Retains its early 20th century appearance; architectural integrity essentially intact.
