KENTUCKY HISTORIC RESOURCES
Individual Inventory Form

Resource # Be-171
Boone County

1. Name of Resource: Hopeful Lutheran Church

5. Location: 6431 Hopeful Road
Florence, KY

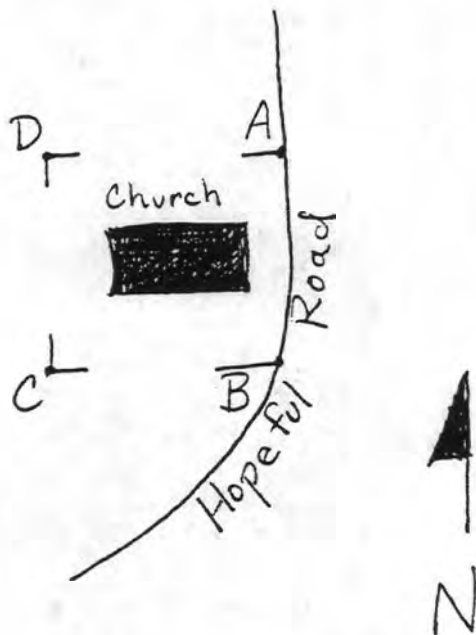
44. Site Plan (and boundary description and justification for N.R. sites):

Beginning at a point on the west side of Hopeful Road, 75' NE of the NE corner of the building, proceed south along Hopeful Road 150' (B). Then proceed west for 150' (C), turning north for 150' (D). Then proceed east 150' to the point of origin (A).

The boundary is a square with approximately 150' side. This includes the church building and sufficient acreage to provide a setting for the property.
